# REMEDIAL ACTION REPORT PCB-Contaminated Fill Pile

**Town Reclamation Yard  
183 Richard White Way  
Fairfield, Connecticut**

Logical Environmental Solutions, LLC  
354 South River Road  
Tolland, Connecticut

December 5, 2017

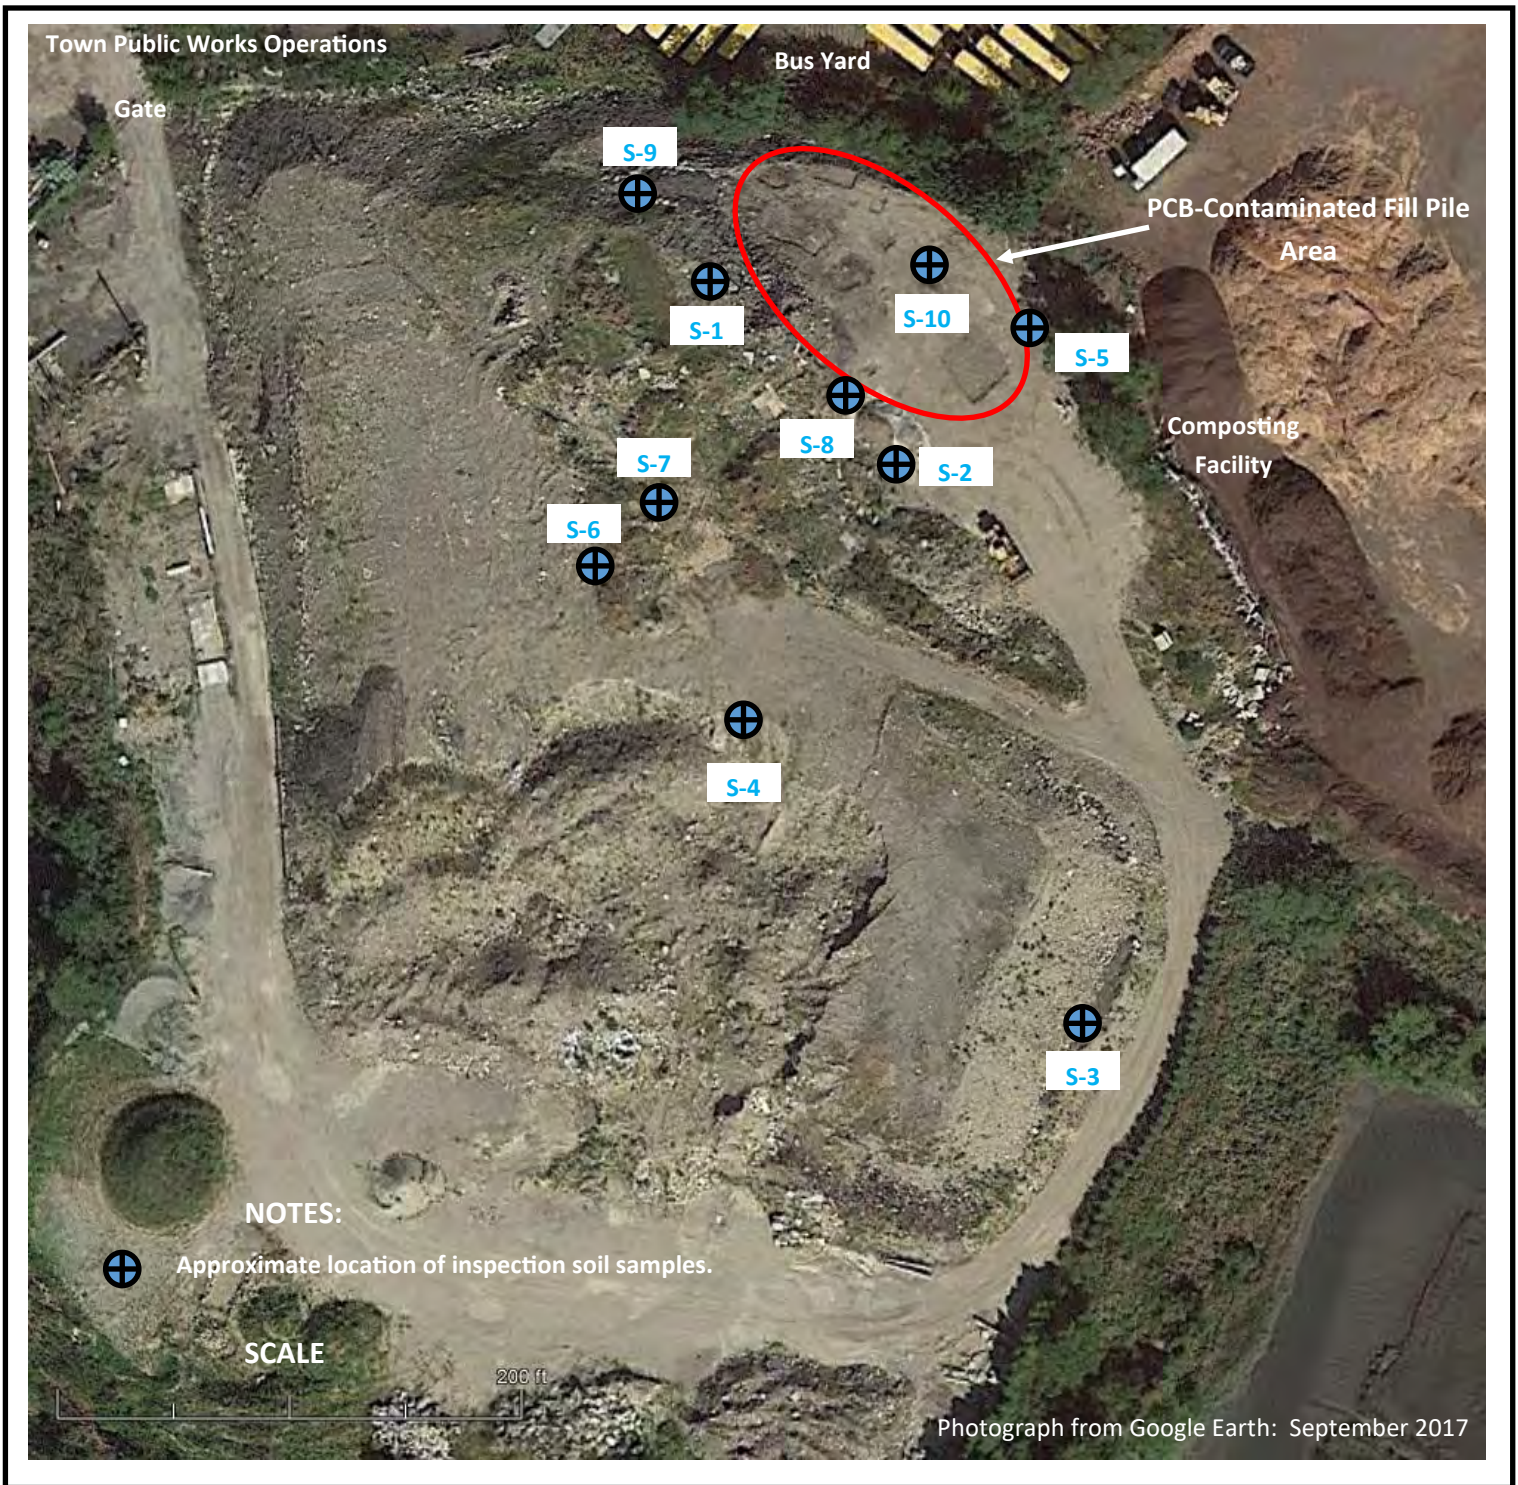
**INSEPTION SAMPLE LOCATIONS (Approximate)**

**September 29 to November 29, 2016**

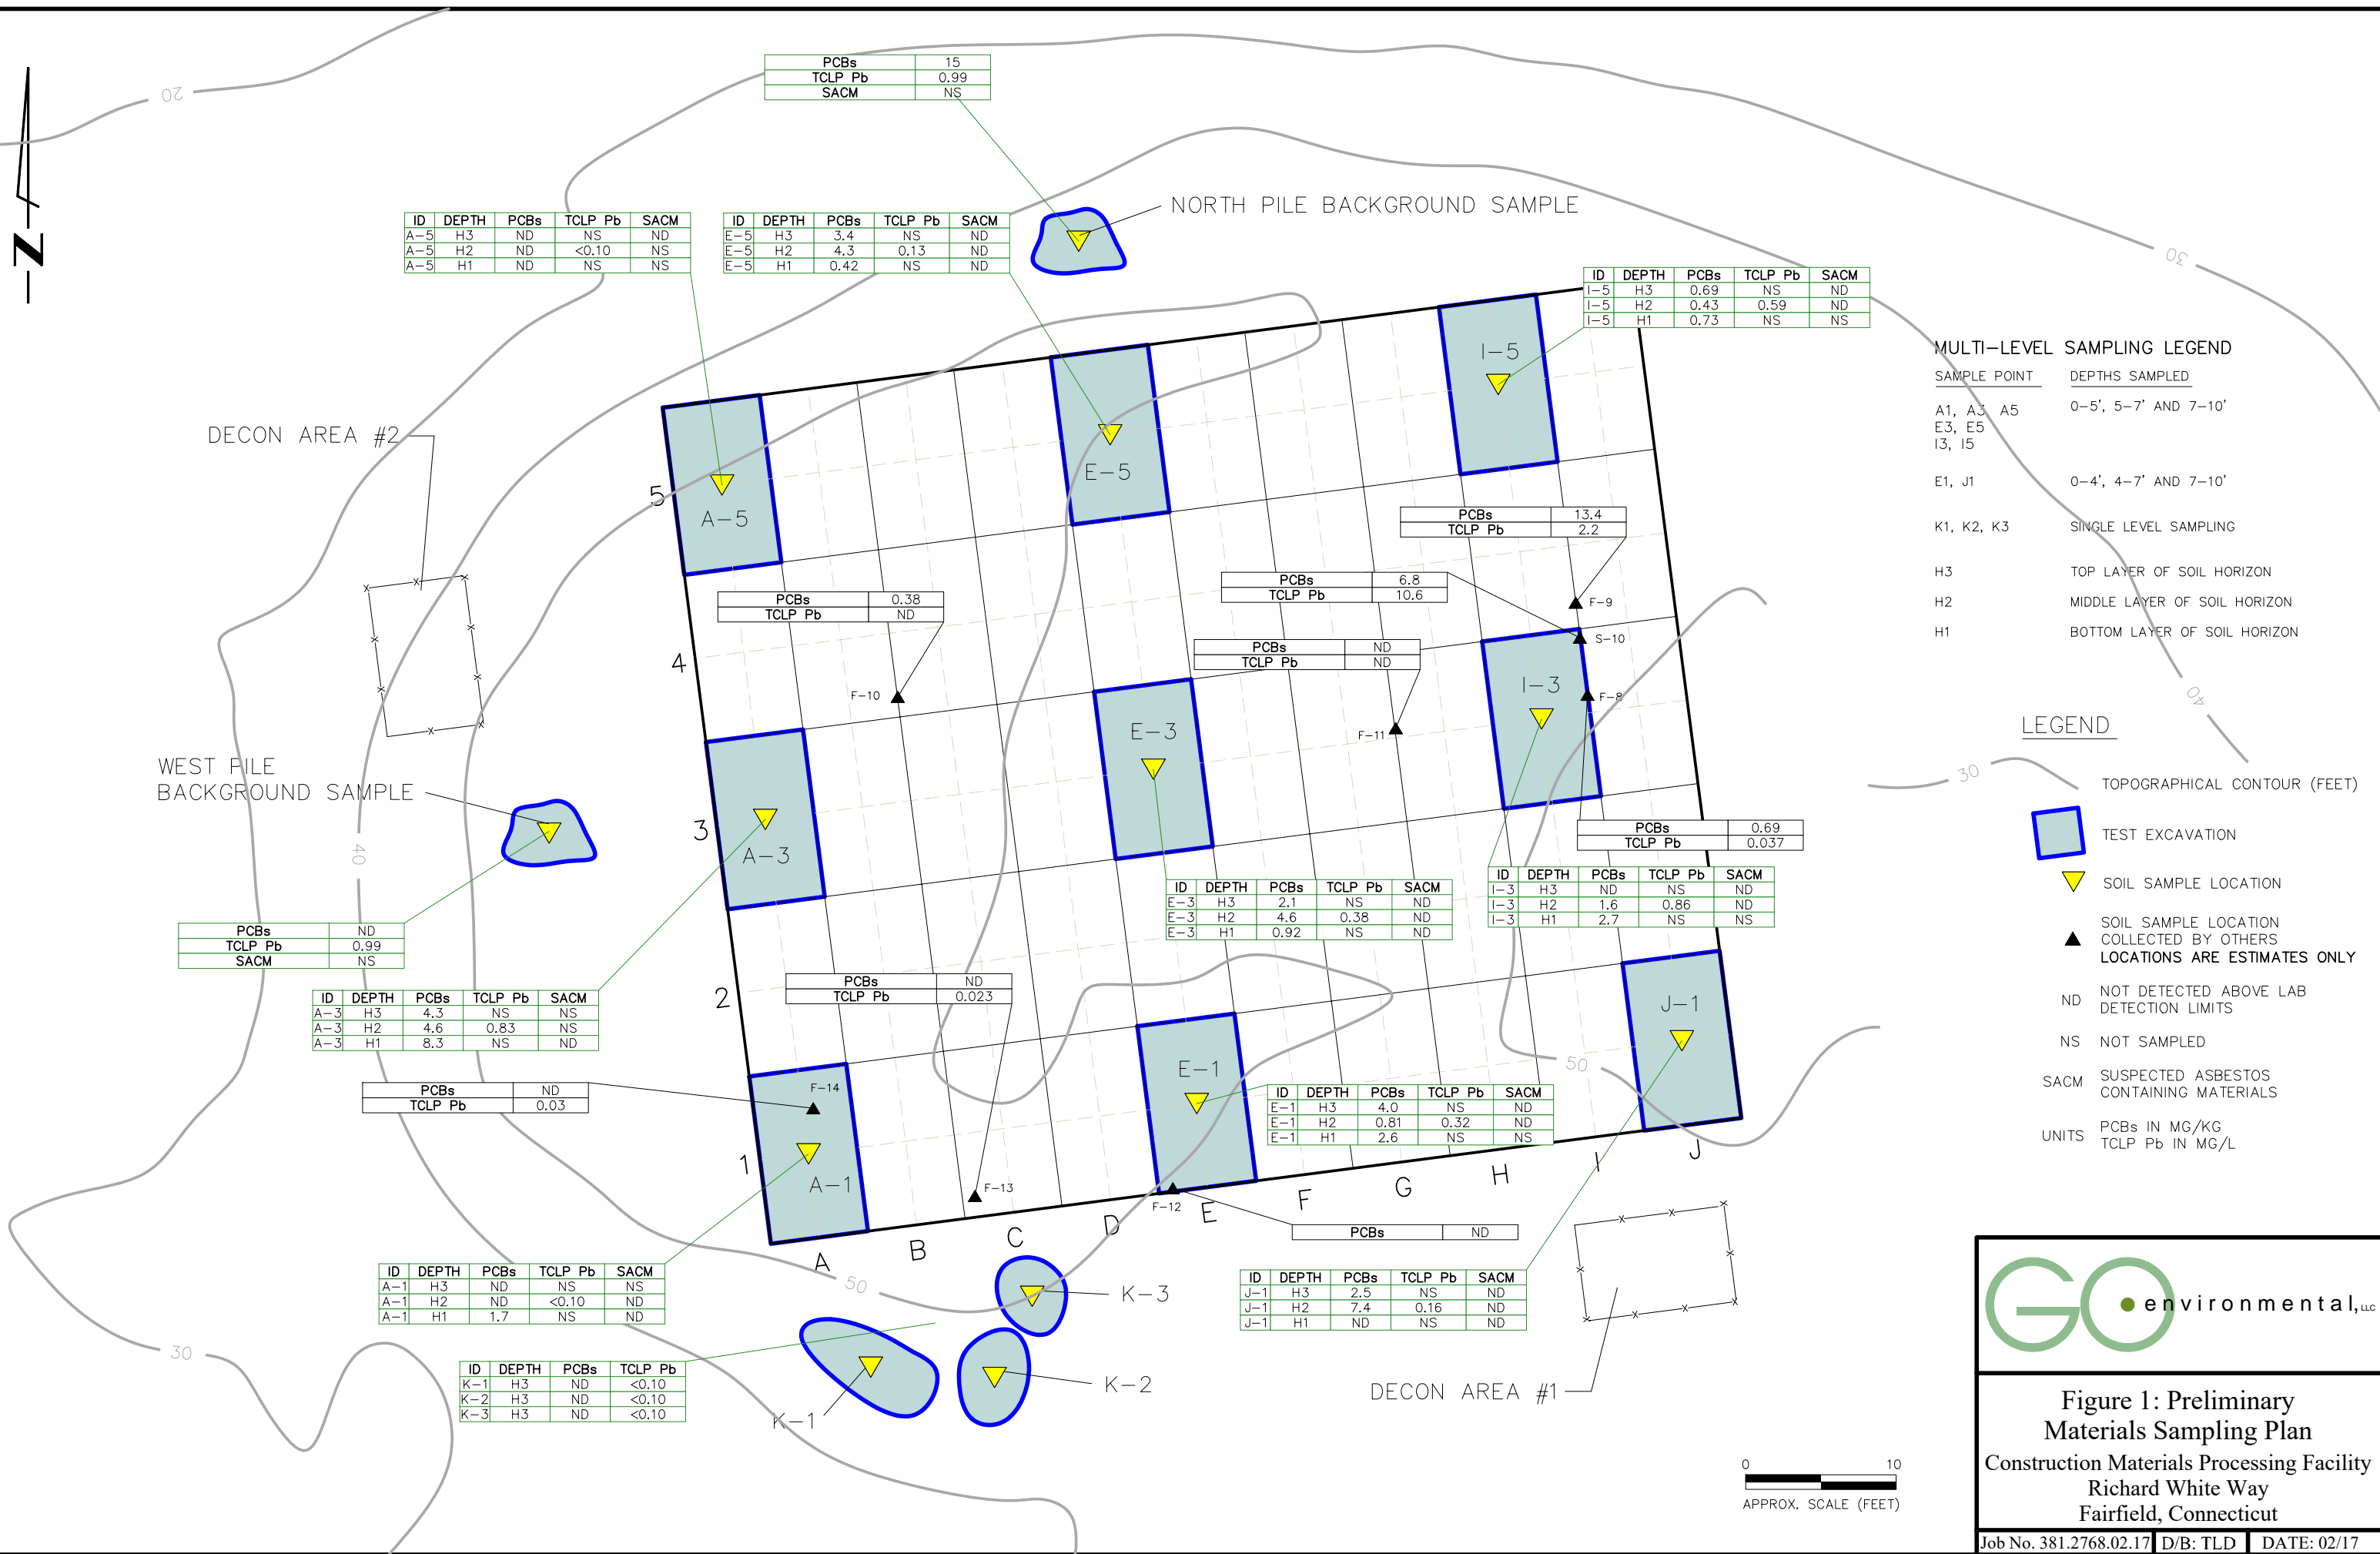
ID	DEPTH	PCBs	TCLP Pb	SACM
A-5	H3	ND	NS	ND
A-5	H2	ND	<0.10	NS
A-5	H1	ND	NS	NS

ID	DEPTH	PCBs	TCLP Pb	SACM
E-5	H3	3.4	NS	ND
E-5	H2	4.3	0.13	ND
E-5	H1	0.42	NS	ND

ID	DEPTH	PCBs	TCLP Pb	SACM
I-5	H3	0.69	NS	ND
I-5	H2	0.43	0.59	ND
I-5	H1	0.73	NS	NS

SAMPLE POINT	DEPTHS SAMPLED
A1, A3, A5 E3, E5 I3, I5	0-5', 5-7' AND 7-10'
E1, J1	0-4', 4-7' AND 7-10'
K1, K2, K3	SINGLE LEVEL SAMPLING
H3	TOP LAYER OF SOIL HORIZON
H2	MIDDLE LAYER OF SOIL HORIZON
H1	BOTTOM LAYER OF SOIL HORIZON

ID	DEPTH	PCBs	TCLP Pb	SACM
A-3	H3	4.3	NS	NS
A-3	H2	4.6	0.83	NS
A-3	H1	8.3	NS	ND

in Accordance with 761.61. The investigation involved the advancement of ten (10) test pits in the eastern portion of the Reclamation Yard to take multi-level samples from the pile for analyses of PCBs using the Soxhlet extraction method EPA 3540C/8082A, leachable (TCLP) lead, and asbestos. Two additional shallow samples were collected from areas anticipated to be beyond the extent of the PCB-contaminated fill for analyses of the same parameters. The investigation was completed by Complete Environmental Services under the direction of LES, GO Environmental, and the Town of Fairfield in February 2017. In summary, the investigation indicated that asbestos-containing materials and RCRA hazardous lead concentrations were not detected in the thirty-two samples collected during this investigation phase. Concentrations of PCBs were detected greater than 1 mg/kg in seventeen (17) of the thirty-two samples collected from the pile, with the highest PCB concentration being 15 mg/kg. A plan depicting the sample locations, and table 10 that summarizes the results of the sample analyses are included in Appendix A.

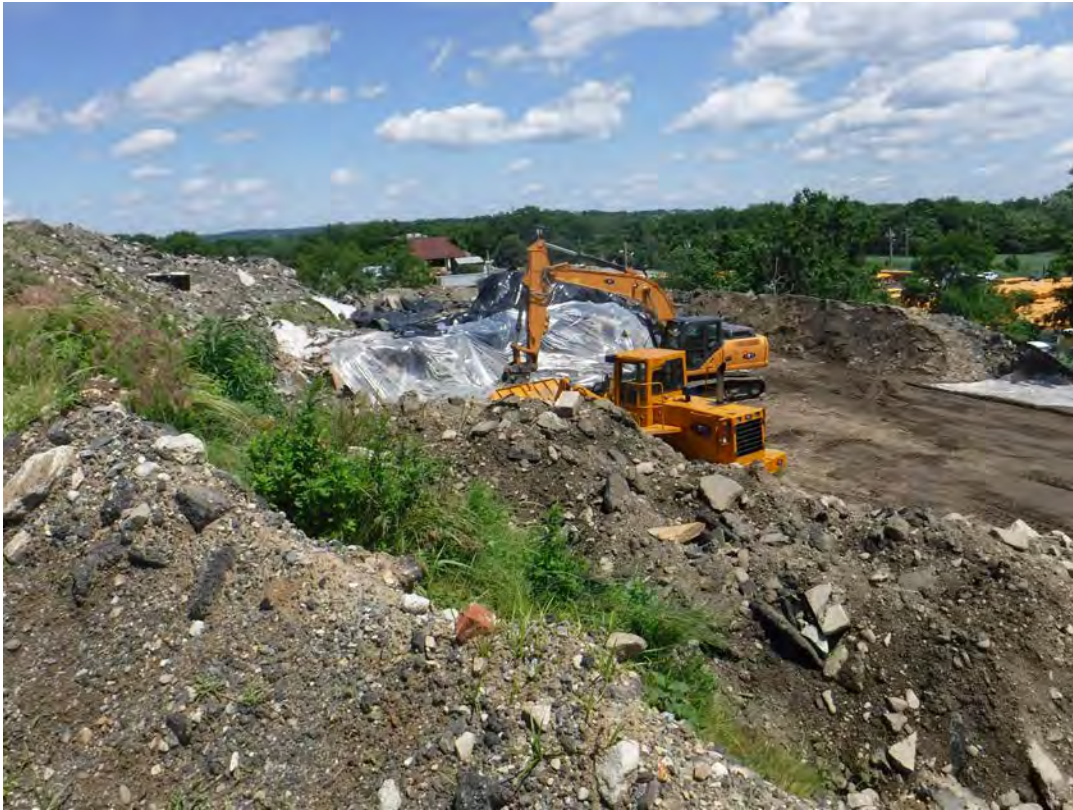
Photograph 1 - June 16, 2017: PCB-contaminated fill pile area covered by polyethylene sheeting.

In response to the November 29, 2016 Reclamation Yard sample results, the Town of Fairfield covered the eastern portion of the pile with polyethylene sheeting to prevent potential stormwater and wind impacts. The Town also directed their stormwater consultant, Osprey Environmental Engineering, LLC, (Osprey) to collect additional samples from the pile area, the stormwater sedimentation basins including the inlet and outlet, and the stormwater channel at Pine Creek. The purpose of the additional soil and sediment samples was to determine if additional areas of PCB-contaminated soil were present in surficial material in the eastern portion of the pile that may be subject to stormwater runoff, and to determine if contaminants were potentially migrating offsite and impacting the adjacent properties and sensitive salt marsh/surface water body receptors. Osprey also collected an air sample to determine if airborne dust from the pile contained elevated concentrations of lead that could adversely impact adjacent property occupants.

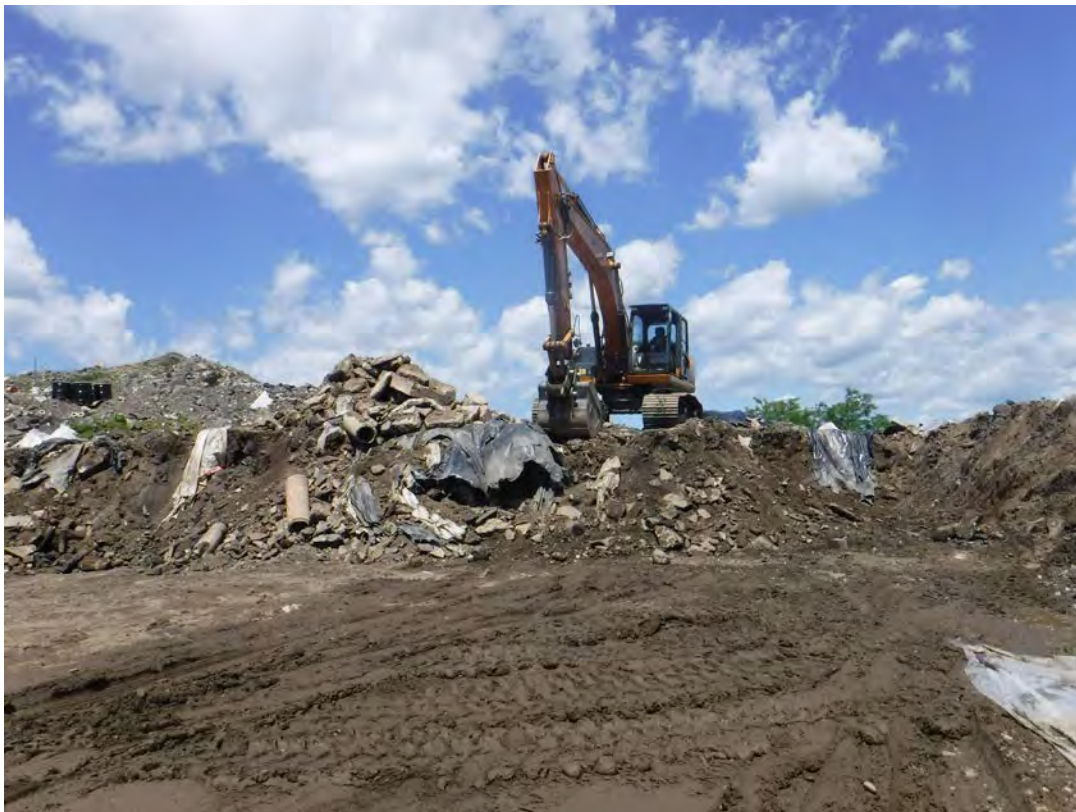
Photograph 2 - June 20, 2017: Segregating the bulky debris from the soil. Debris was placed on polyethylene sheeting (lower right) prior to sampling by LES.

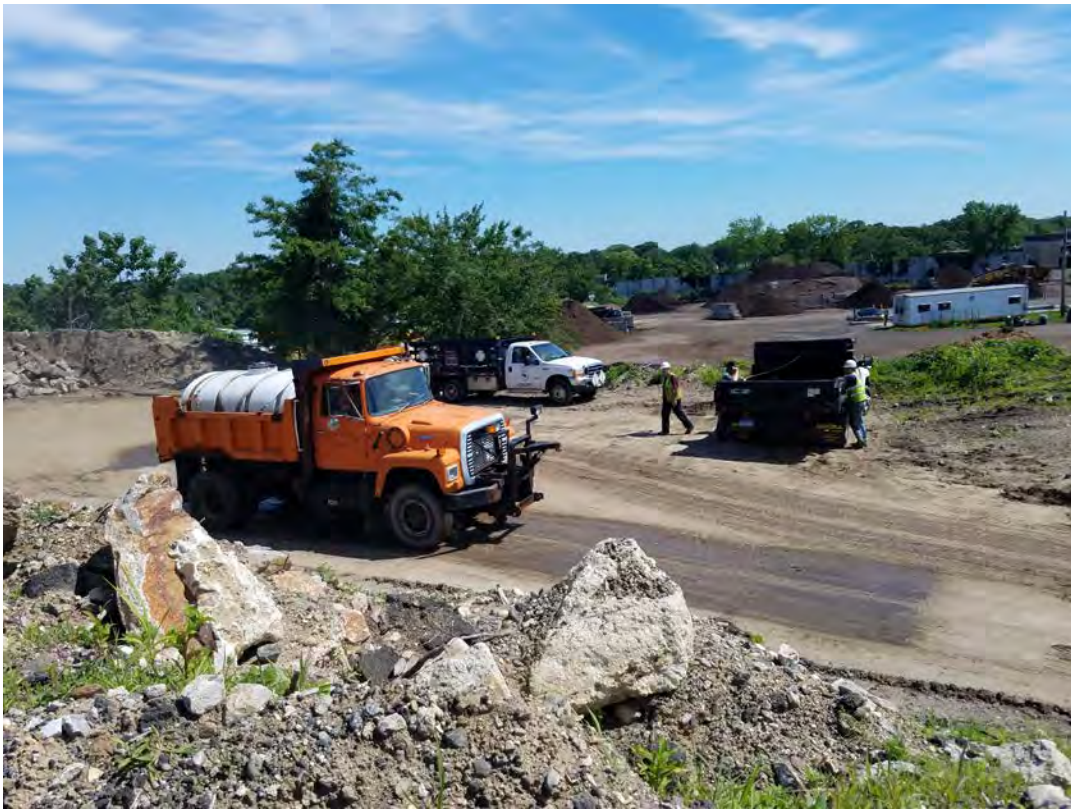
Photograph 3 - June 22, 2017: Dust control measures undertaken by Town using water truck.

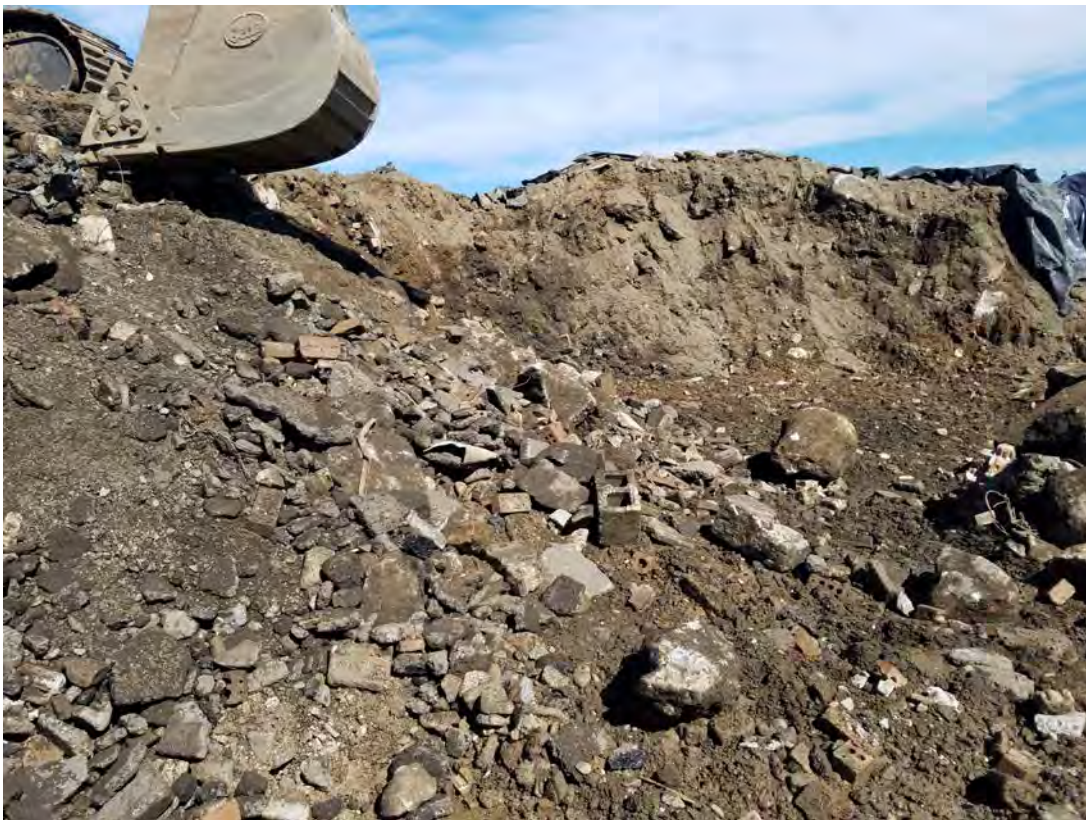
Photograph 4 - June 22, 2017: Type of fill material present in PCB-contaminated area.

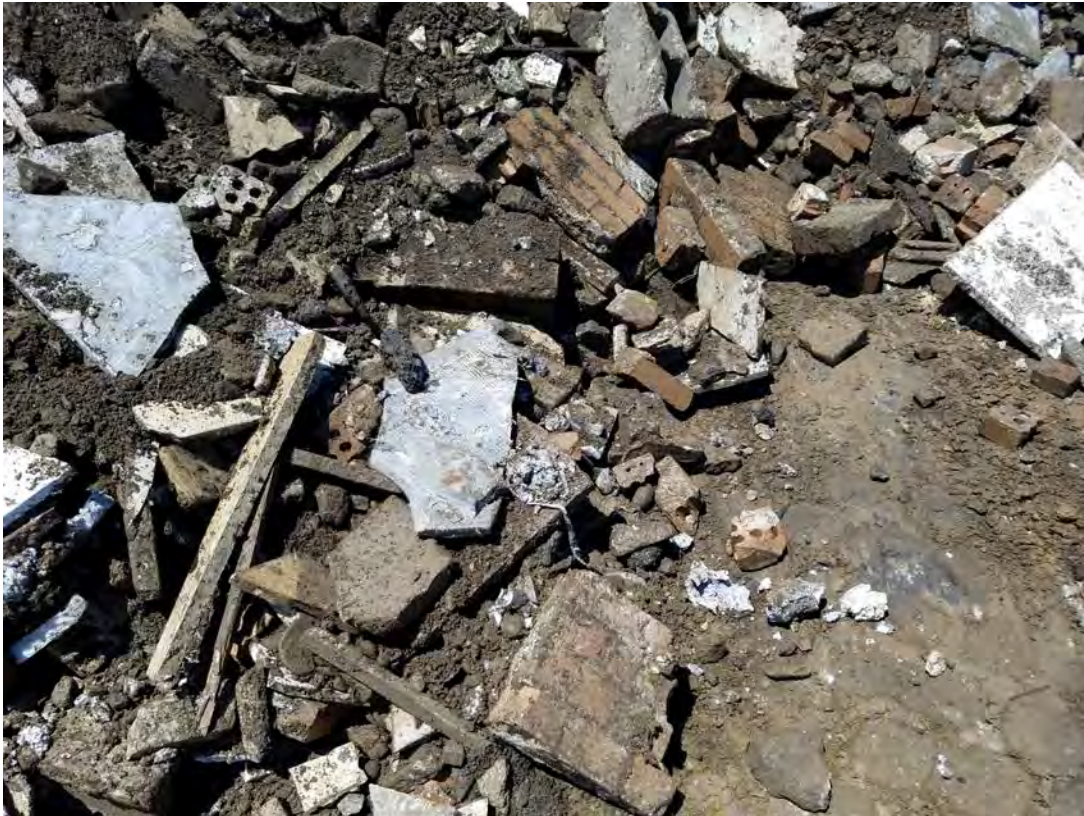
Photograph 5 - June 23, 2017: Fill material present in PCB-contaminated area.

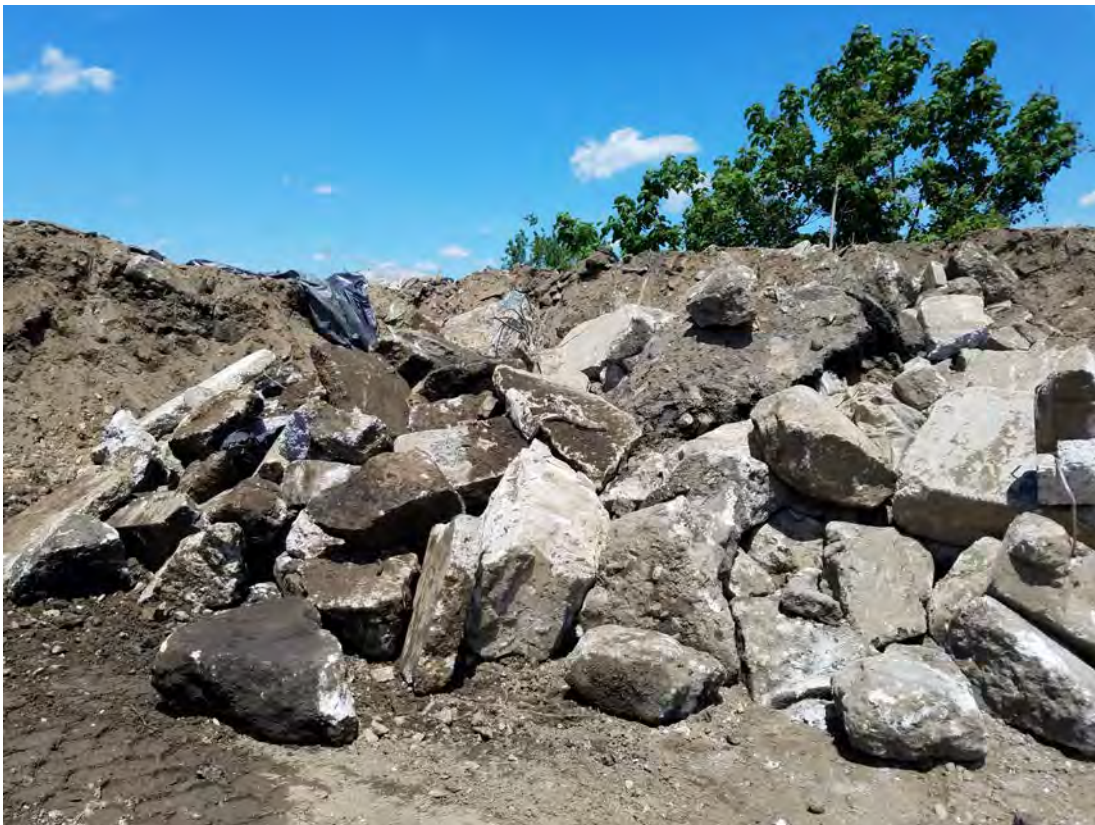
Photograph 6 - June 22, 2017: Additional bulky debris segregated from pile area.

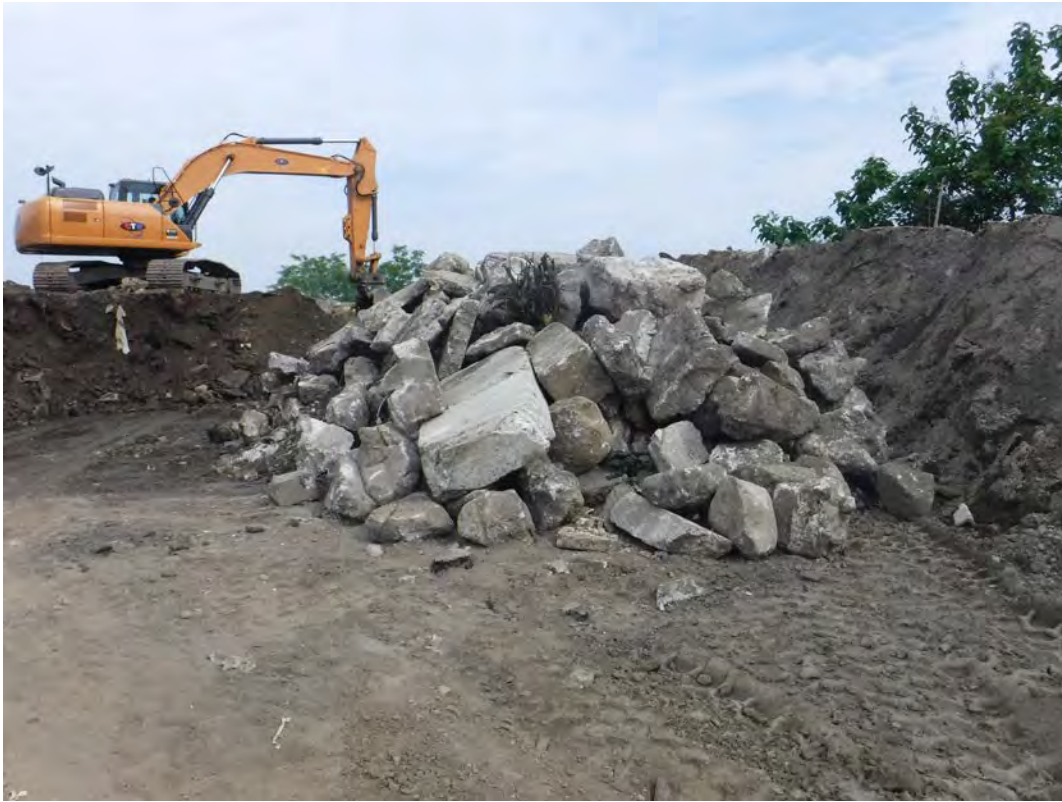
Photograph 7 - June 23, 2017: Final pile of bulky debris to be placed on polyethylene prior to sampling.

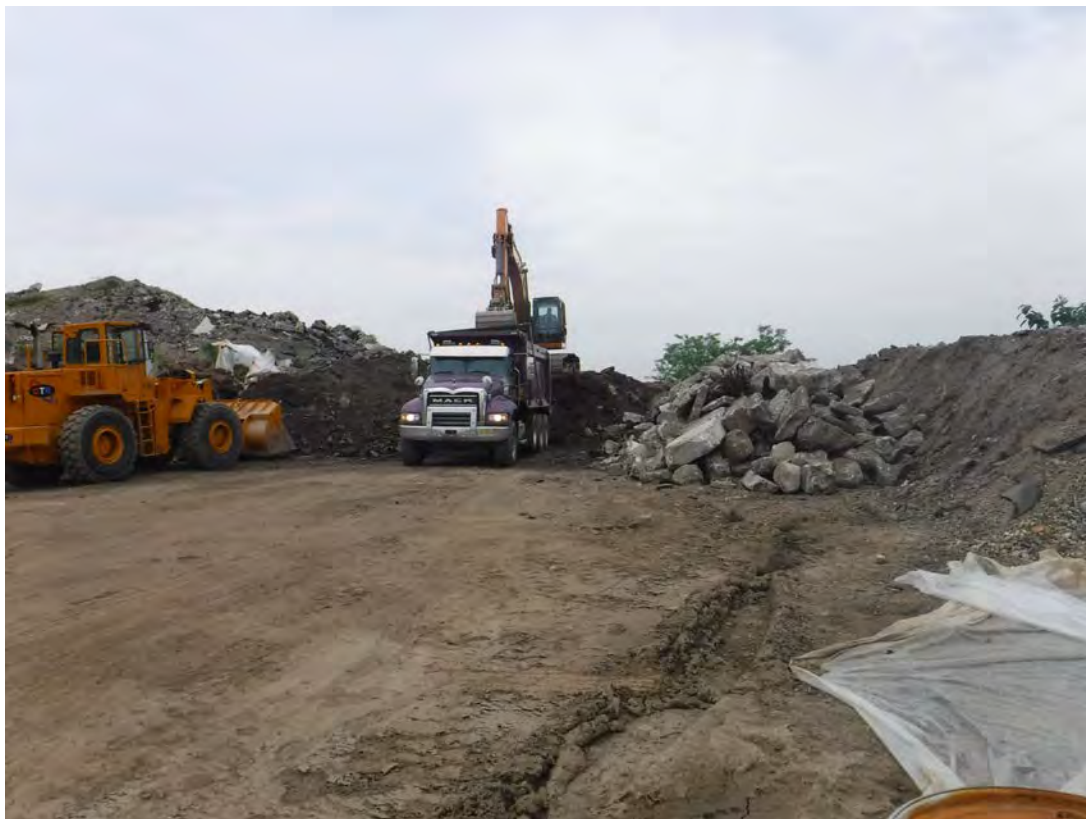
Photograph 8 - June 23, 2017: Triaxle truck being loaded for transport of soil to Hazelton Creek disposal facility.

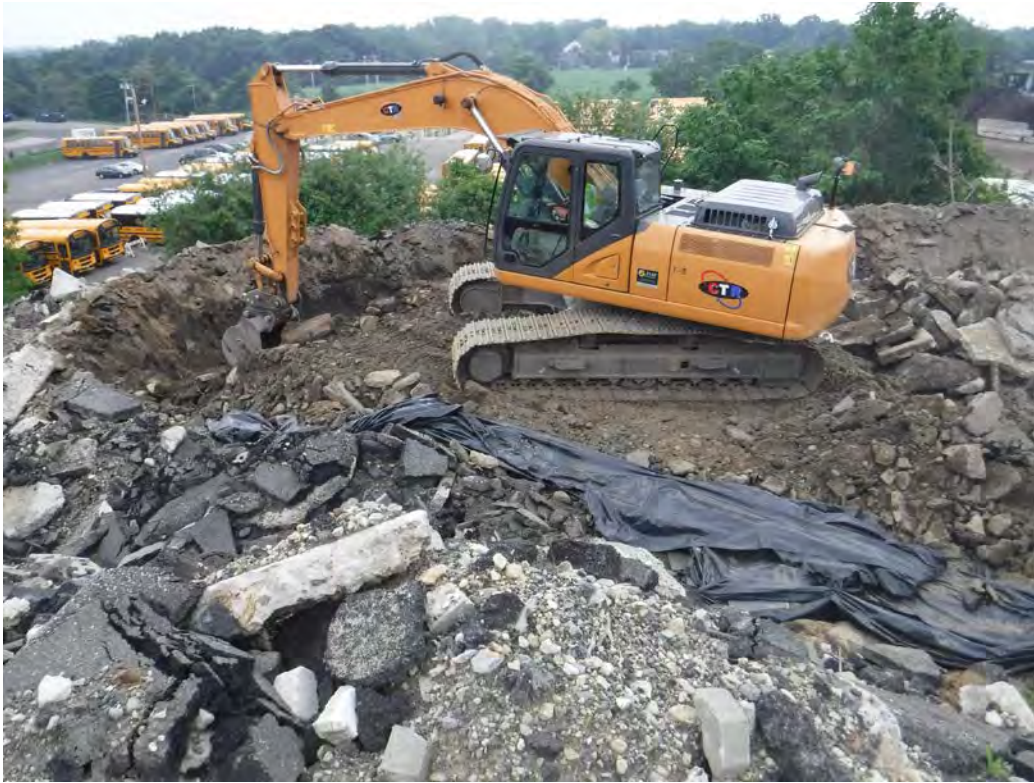
Photograph 9 - June 23, 2017: Excavating soil from the north sidewall (to left) and bottom of the PCB-contaminated area.

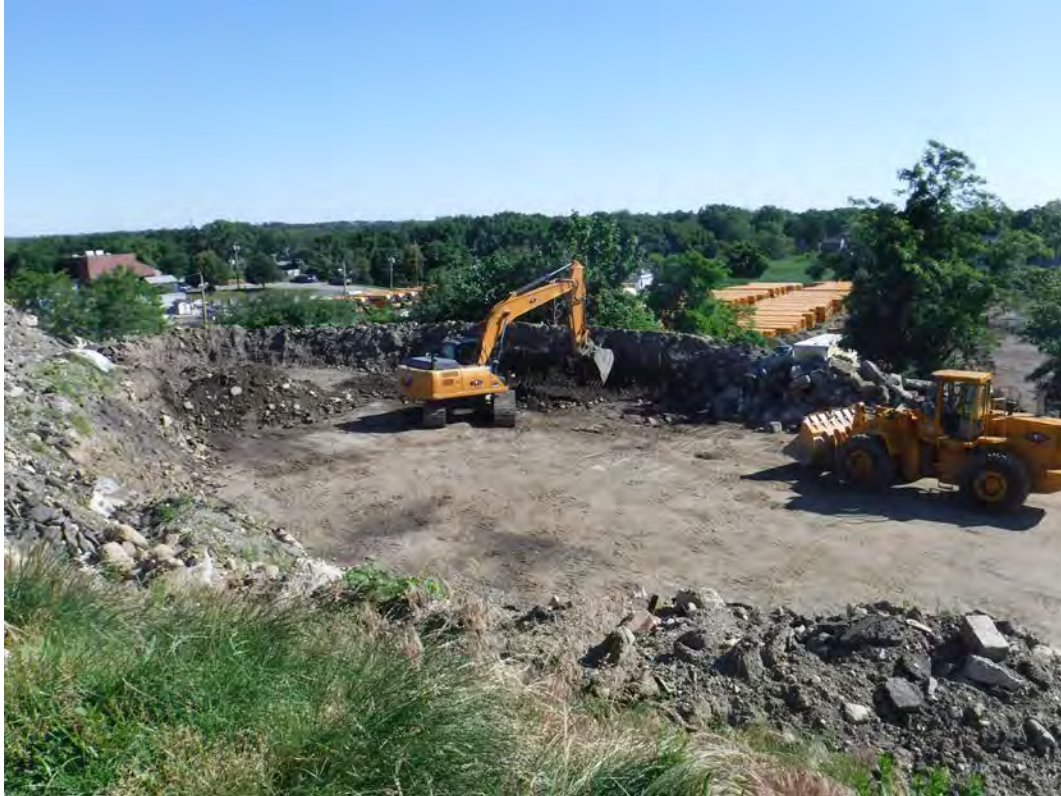
Photograph 10 – June 26, 2017: Excavating soil from the eastern sidewall and bottom of the PCB-contaminated area.

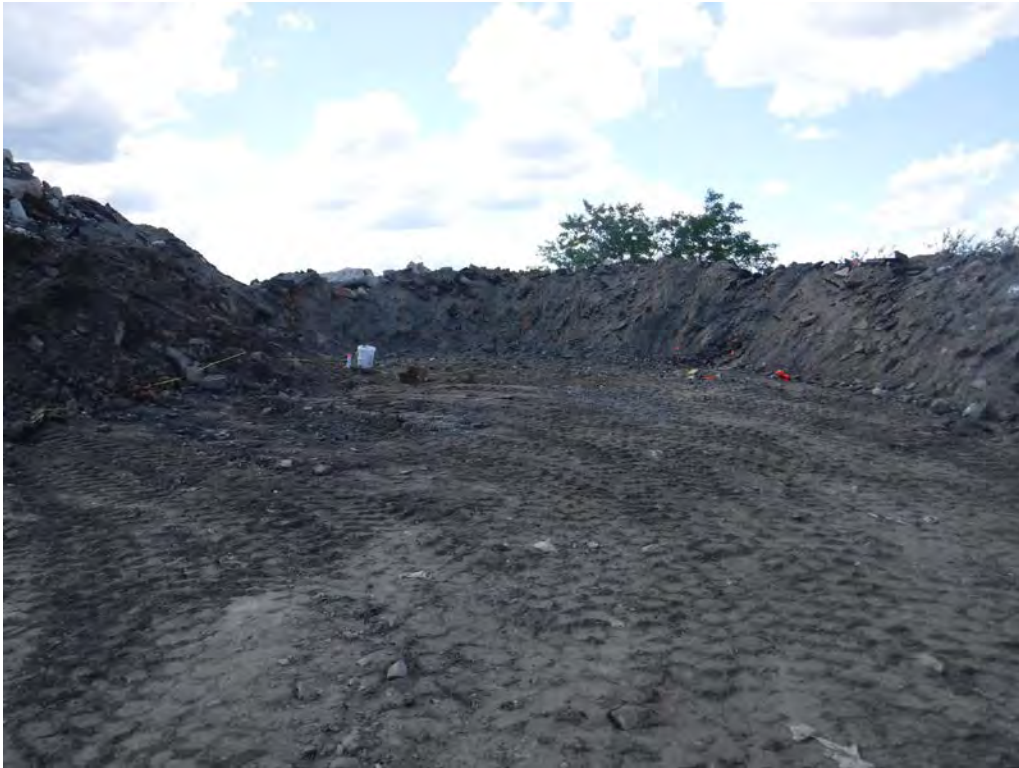
Photograph 11 - June 26, 2017: Initial 1.5-meter sampling grid being set up for western (left), northern (center), and eastern (right) sidewalls and bottom.

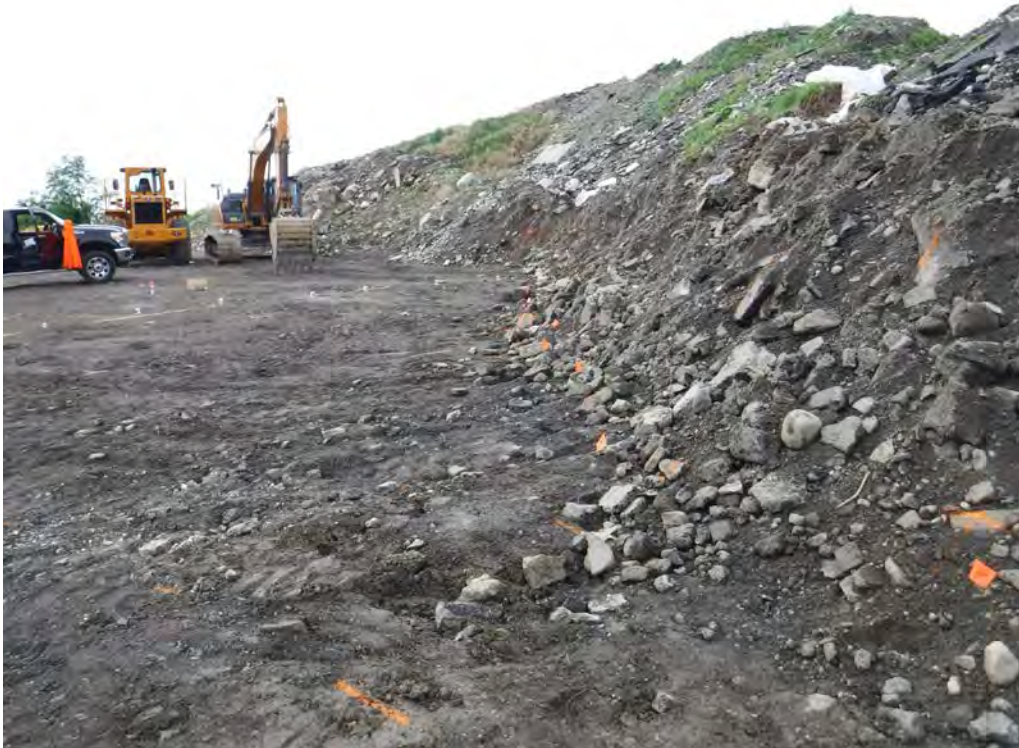
Photograph 12 - June 27, 2017: Sampling grid set up for western sidewall and bottom.

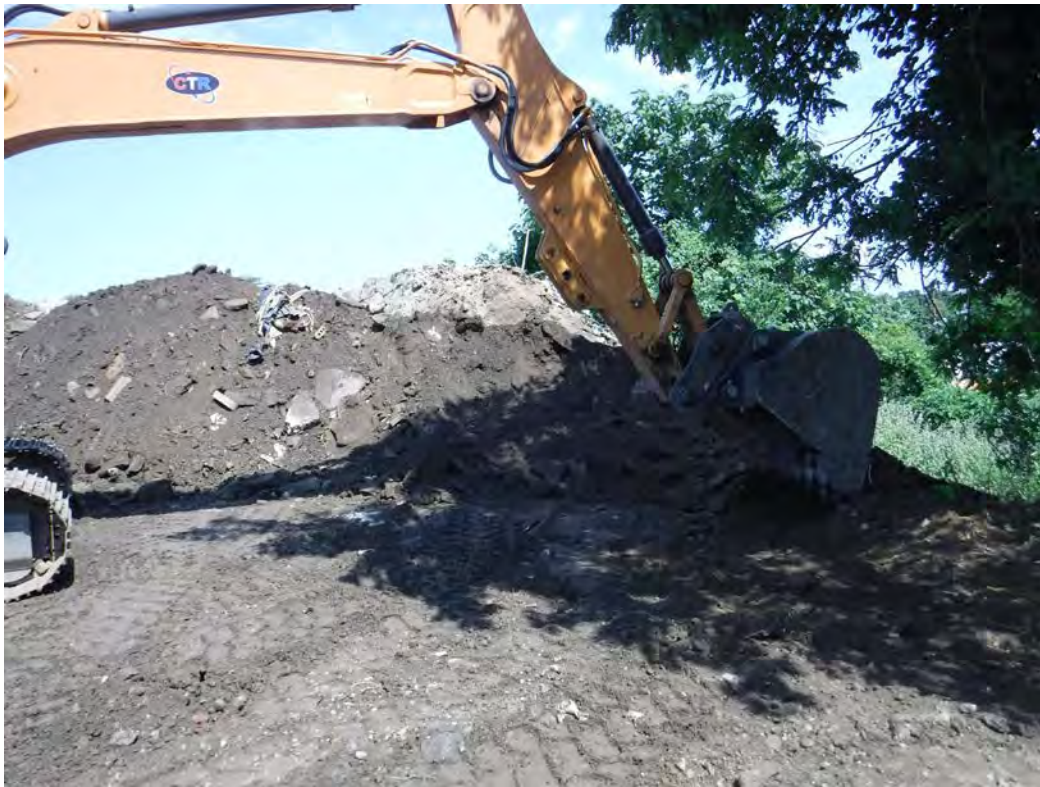
Photograph 13 – July 18, 2017: Start of the excavation of the entire eastern sidewall of the pile area for subsequent offsite disposal.

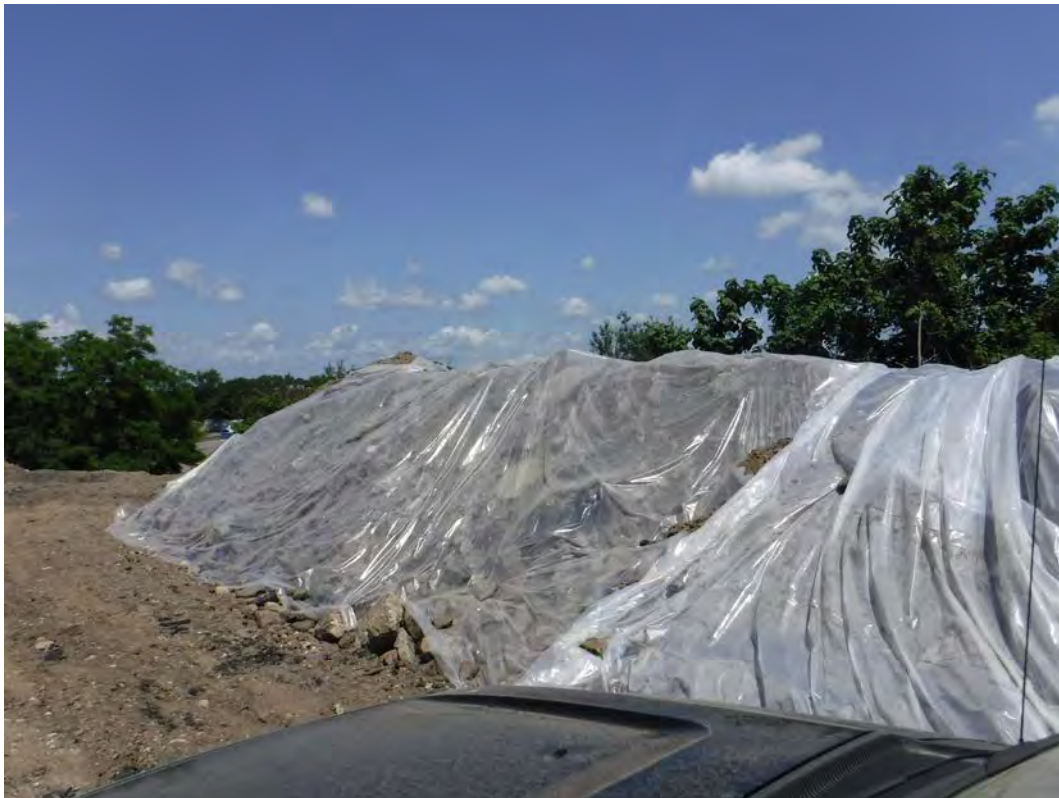
Photograph 14 – July 18, 2017: Soil from the eastern sidewall covered by poly and ready to be loaded for offsite disposal.

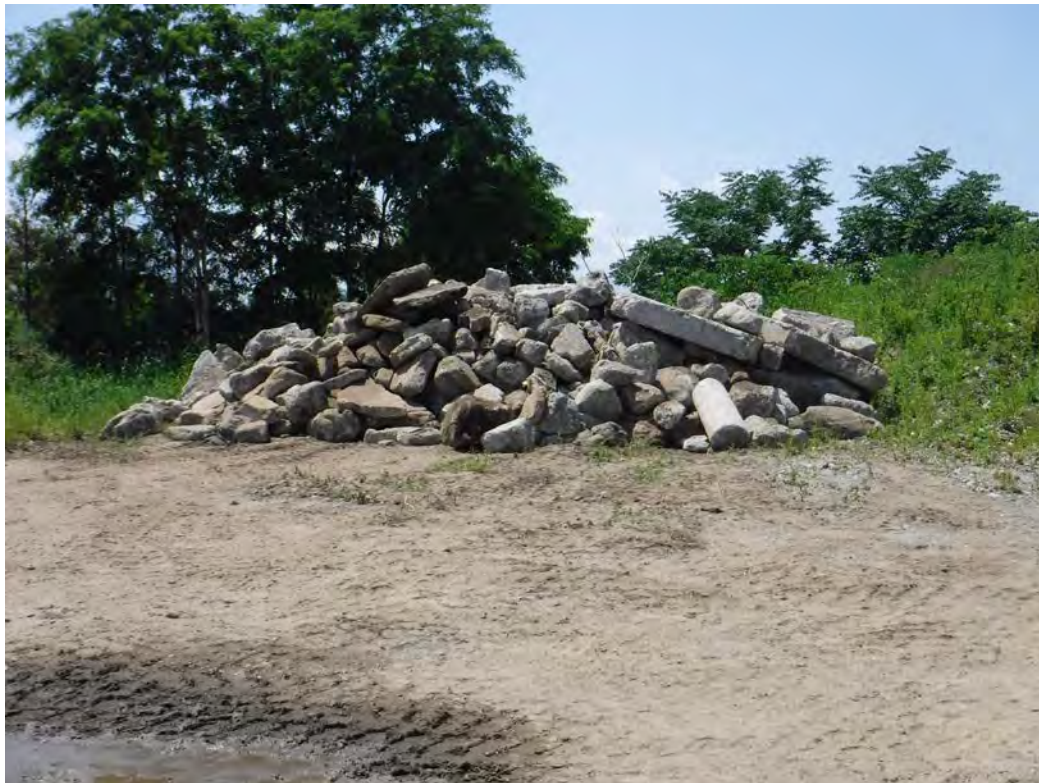
Photograph 15 – July 18, 2017: Pile of the bulky debris that tested ND for PCBs and was moved to the southwest region of the Reclamation Yard.

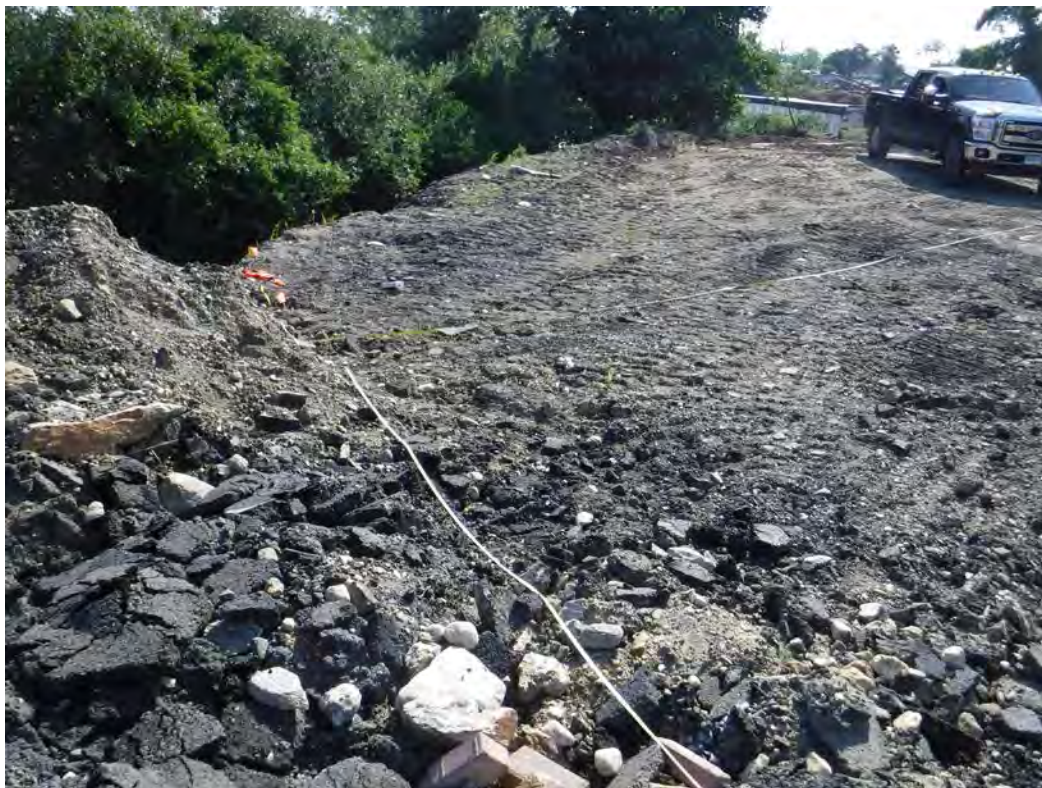
Photograph 16 – August 16, 2017: Laying out the grid for the additional confirmation soil sampling of the pile bottom.

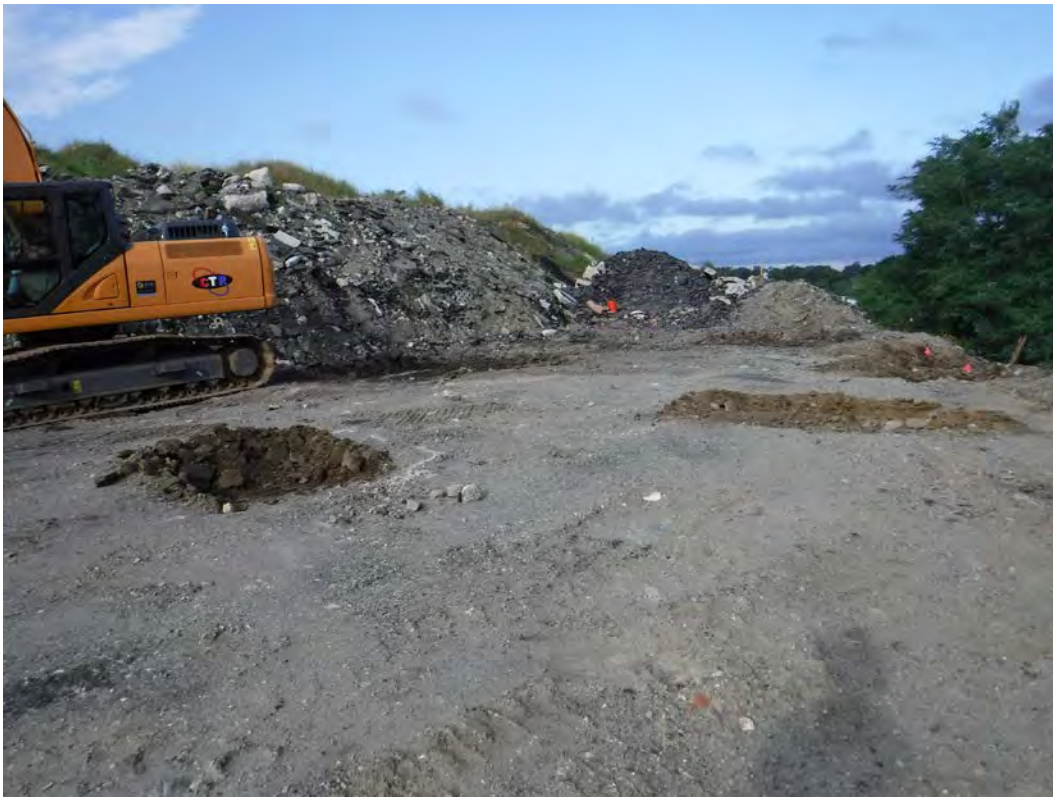
Photograph 17 – September 19, 2017: “Hot-spot” remediation of bottom sample areas that contained PCBs greater than 1 mg/kg.

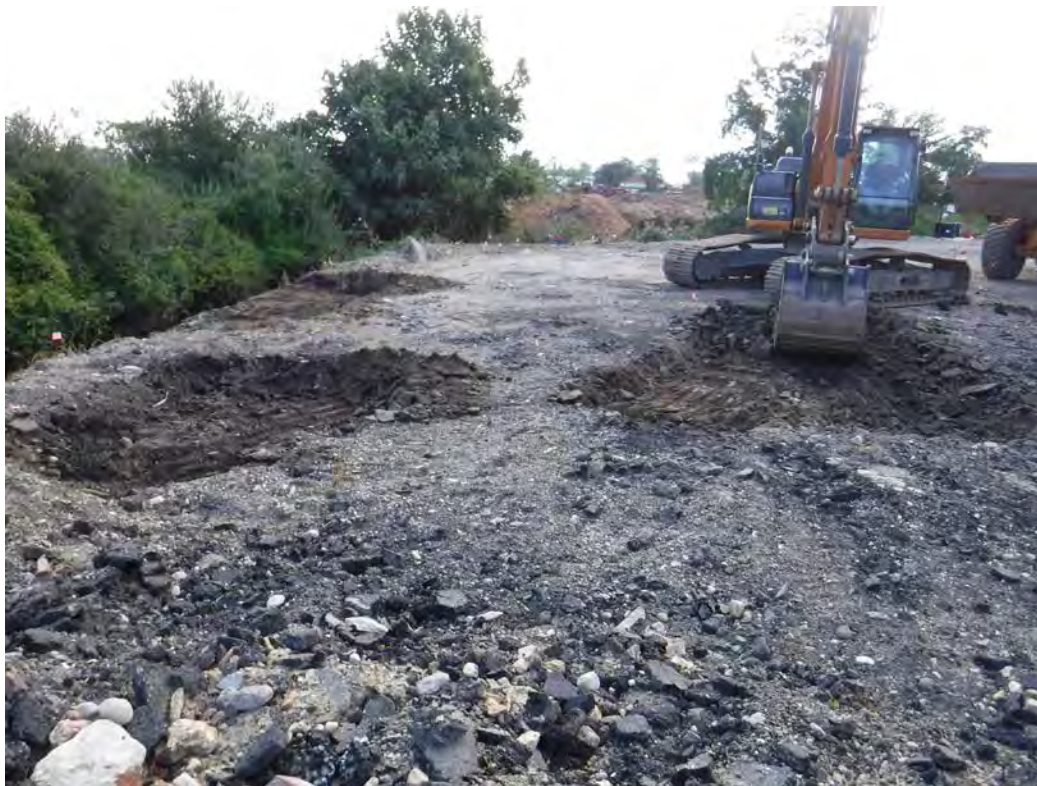
Photograph 18 – September 19, 2017: “Hot-spot” remediation of bottom sample areas that contained PCBs greater than 1 mg/kg.
