# REMEDIAL ACTION REPORT PCB-Contaminated Fill Pile

**Town Reclamation Yard  
183 Richard White Way  
Fairfield, Connecticut**

Logical Environmental Solutions, LLC  
354 South River Road  
Tolland, Connecticut

December 5, 2017

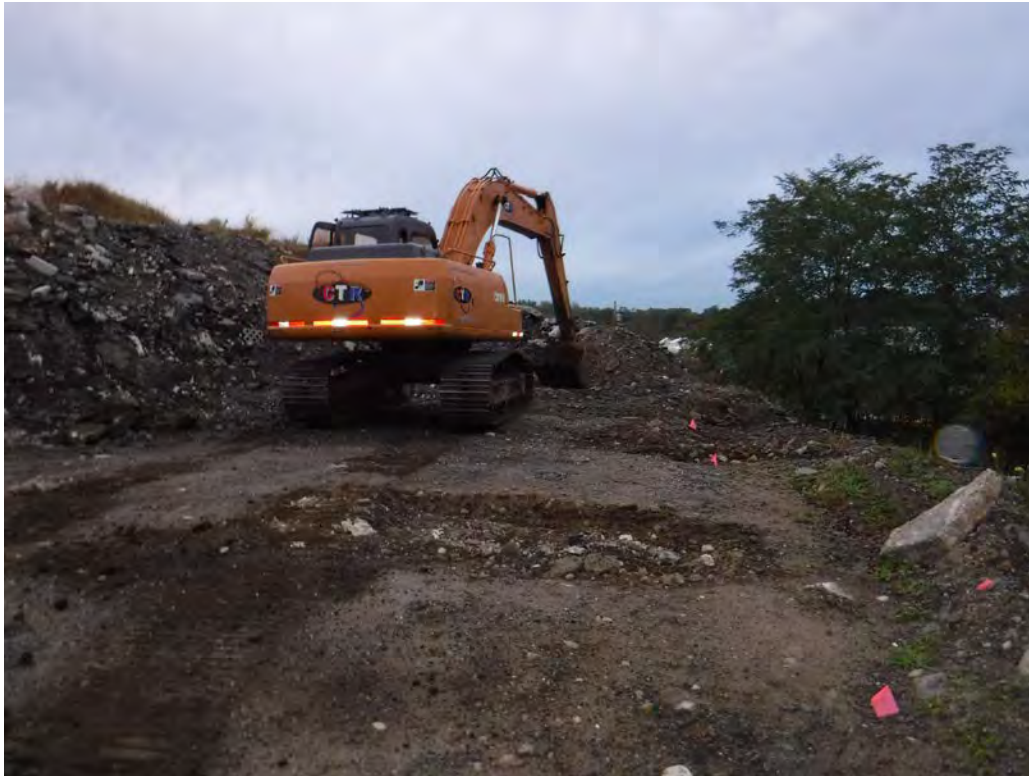
Photograph 19 – October 11, 2017: Final “hot-spot” remediation of bottom sample areas that contained PCBs greater than 1 mg/kg.

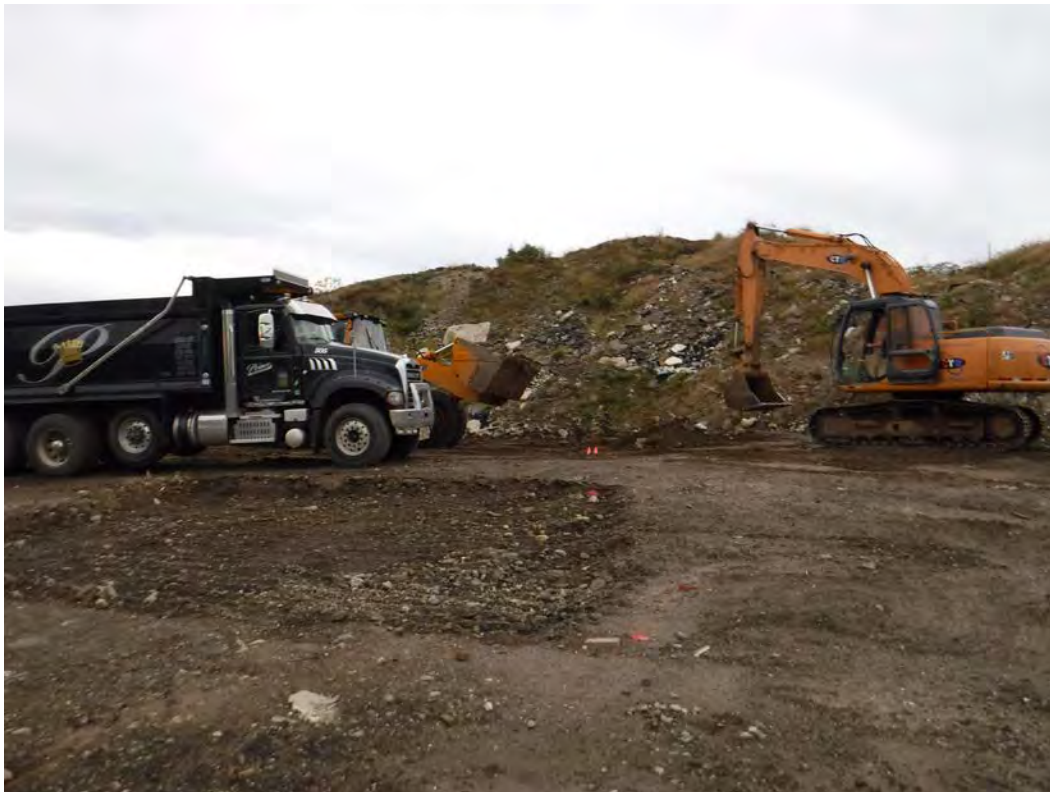
Photograph 20 – October 11, 2017: Final truck being loaded with PCB contaminated soil for offsite disposal.
